Manhole Inspection Summary

Manhole # S04YY1013MH

Location Address: **3701 BARTWOOD RD**

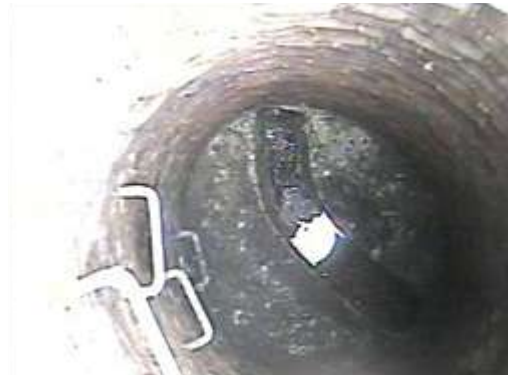
Top View

Surcharge ☒ **Evidence Of Surcharge** Depth: **1.5** (ft.) ☐ Active Surcharge Present

Evidence of surcharge - Bench debris.
Channel debris.

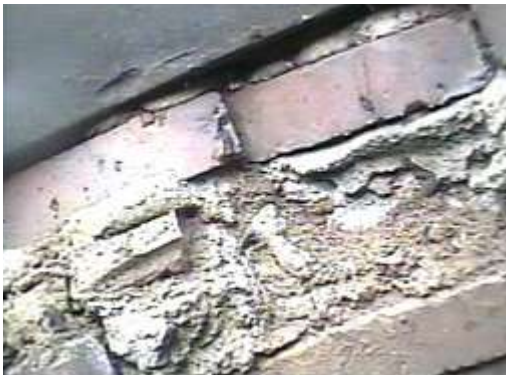
Defect

Frame Offset: **1** (in.) Condition: ☐ Sound ☐ Cracked ☒ **Leaks**

Condition: ☐ Sound ☐ Cracked ☐ Root Intrusion ☒ **Loose Brick** ☒ **Deteriorated**

Infiltration: ☐ None ☒ **Joint** ☐ Cracks ☒ **Mortar** ☐ Roots ☐ Wall

Frame leaks. Adjustment deterioration
and loose brick. Adjustment infiltration.

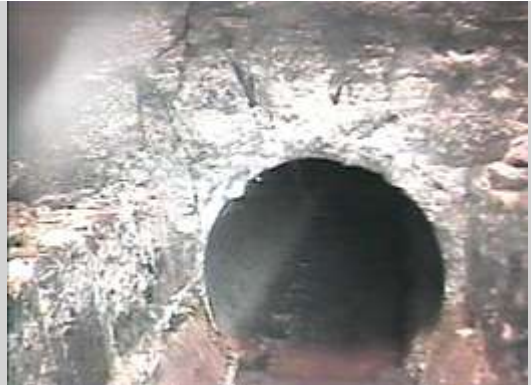
8 in. Circular Gravity Sewer Pipe Out @ 12 O'Clock

Barrel deterioration, cracks and infiltration.

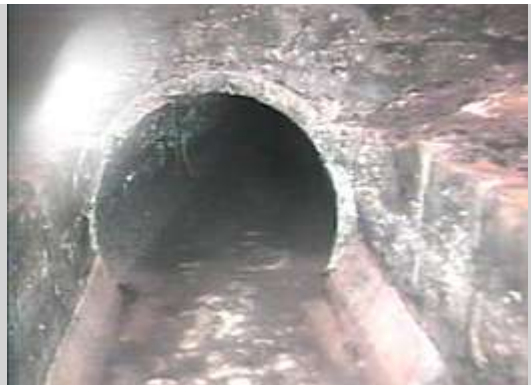
8 in. Circular Gravity Sewer Pipe In @ 4 O'Clock

Comments **The O12 pipe picture also shows grease deposits in the Channel and on the pipe face.**

Deposits: ☐ None ☐ Mud ☐ Sludge ☒ Debris ☒ Grease

Silt Depth: **0** (in.) Deposits Extent: **Light**

Infiltration: **Evidence** Pipe Seal Cond: **Unknown**
